NAME OF PLACE	<i>SALT RIVER HALL</i>
ANY FORMER NAMES	
ADDRESS OR LOCATION	<i>Chester Pass Road, South Borden</i>
CURRENT OWNER	
CONTACT DETAILS	
ORIGINAL OWNER

HERITAGE ASSESSMENT
&
CONSERVATION PLAN
FOR
SALT RIVER HALL

Prepared by Michael Green
Hammond & Green Architects
87 George Street
EAST FREMANTLE WA 6158

September 1994

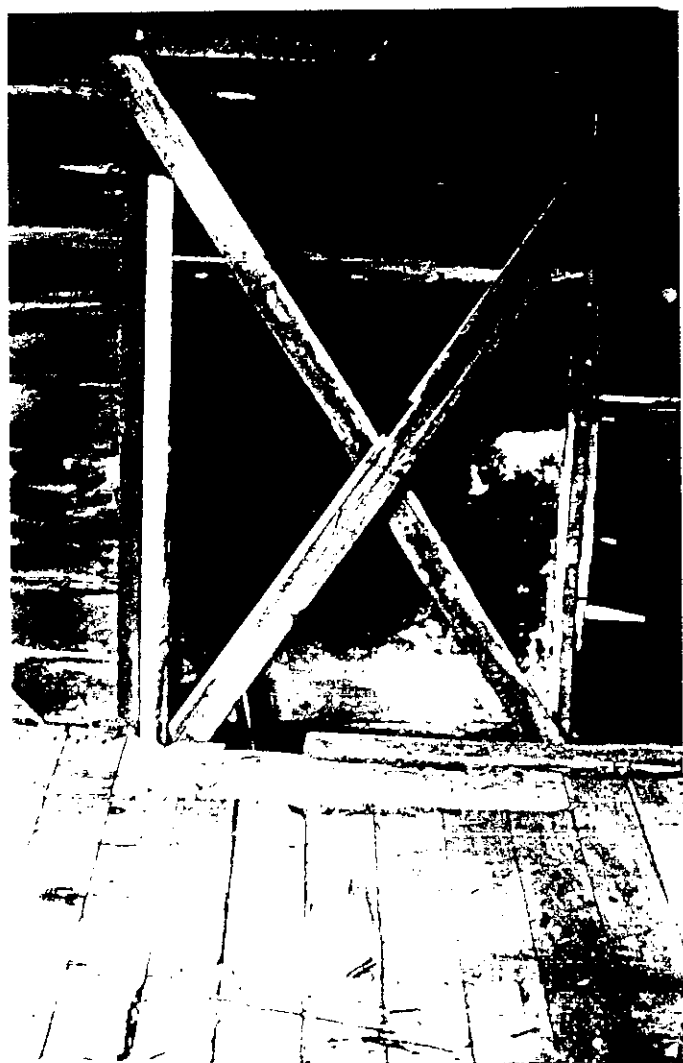
Fireplace

May 1926: A pot belly stove (now removed) was provided and was positioned in the North West corner of the main hall.

The pot belly, recently removed may still exist in someone's farm shed and if so should be restored and reinstated. If the original heater cannot be located a new slow combustion heater located in the same position and using the existing flue would provide essential heating to allow winter use of the hall. The northern ante room is important as it shows the historical progression of additions to the hall but it is not significant architecturally and the deteriorated condition of the internal linings and flooring may be sufficient cause for its removal if the space is not required.
